**Final Investigation Report**

**DHL - ES 160 – B767-300  
A9C - DHAB**

**18<sup>th</sup> September 2023**

**BRHIA (OLBA) - Lebanon**

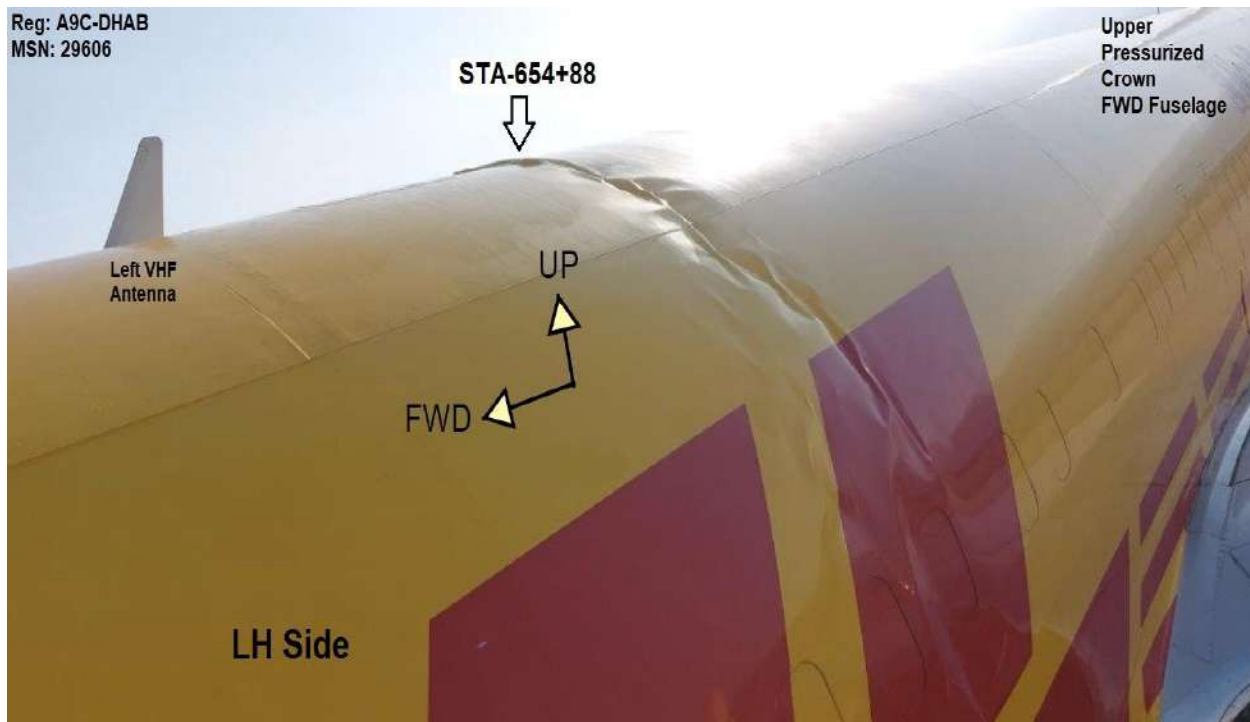
The engineer on board went down and conducted an inspection of the nose and main landing gears, as well as the engines. No damage was found. While still inspecting the landing gears, he was alerted by ground staff of a crinkle in the fuselage. The Engineer’s inspection of the fuselage detected wrinkled/buckled fuselage skin at STA 654 (between the wing forward section and aft of the Cargo Door) on both left and right side of the fuselage and top shell upper pressurized fuselage crown. (Refer to figure 1 & 2)

**Figure 1: Top and LH side view of the damage to the fuselage**

The aircraft fuselage suffered severe damage in the form of wrinkled/buckled fuselage skin at station 654 on both left and right-hand side and on the top shell pressurized fuselage crown. In addition, some oil traces were identified on the LH main landing gear (Figure 1 & 6 below).

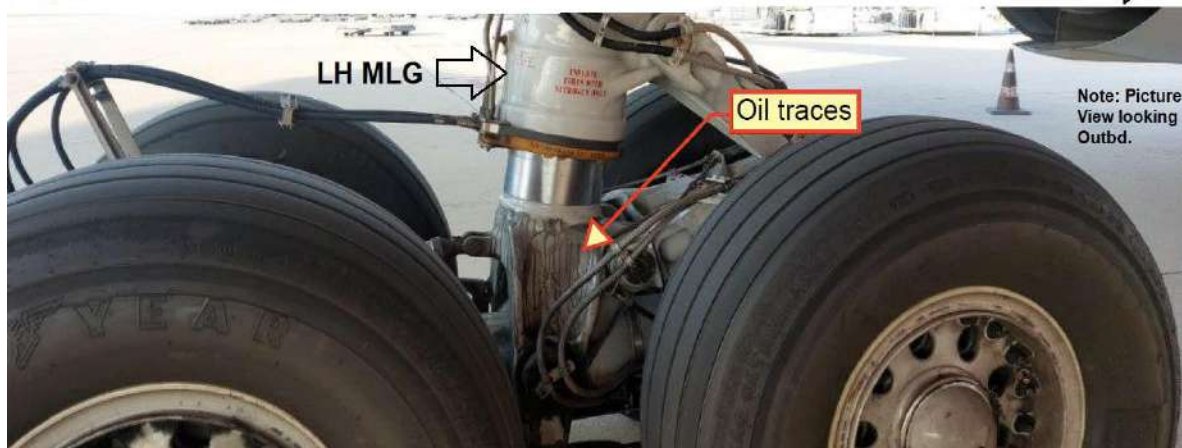
**Figure 2: LH Main Landing Gear oil traces**

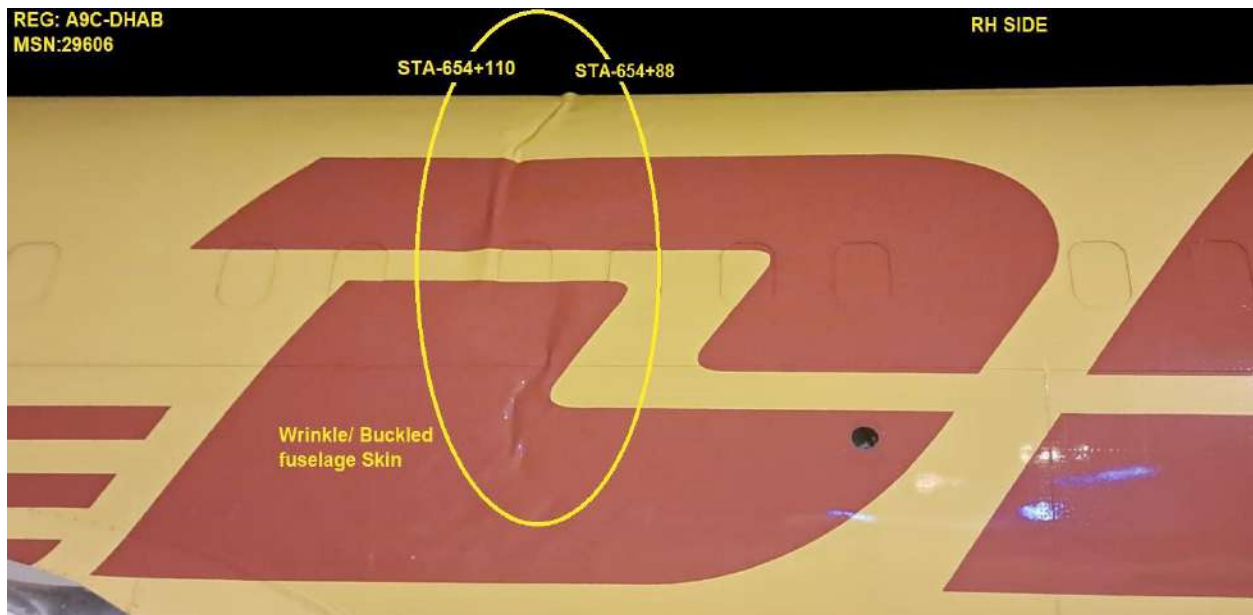
Below is the detailed position of the damage as received from the Boeing AOG team that inspected the aircraft: (Refer to Figures 1 above and 3 to 10 below)

- Skin panel +654 to 786 and STR-26L TO 17L
- Skin panel +654 to 786 and STR-17L TO 8L
- Skin panel +654 to 786 and STR-8L TO 2R
- Skin panel +654 to 786 and STR-2R TO 8R
- Skin panel +654 to 786 and STR-8R TO 17R
- Skin panel +654 to 786 and STR-17R TO 26R
- Stringers 21L to 17L
- Stringers 16L to 8L
- Stringers 7L to 1R
- Stringers 2R to 7R
- Stringers 8R to 16R
- Stringers 17R to 23R
- Shear ties and stringer Clips
- Frames detail, frame assembly
- Tubing, static lines
- Tubing, instrument lines
- Tubing, smoke detection, Main Deck Cargo
- Bracket assy, cargo ceiling liner support
- Bracket – ECS ducts Main Deck Car

**Figure 3: RH side view of the damage to the fuselage**

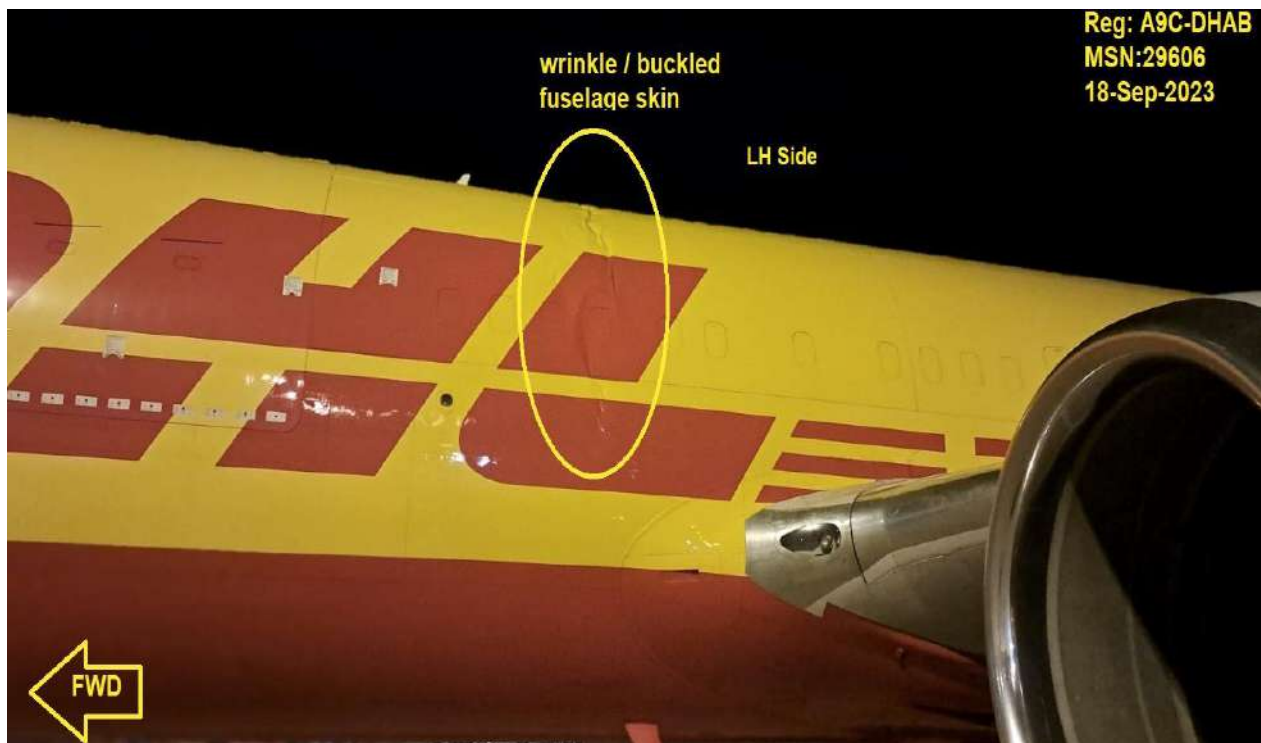
**Figure 4: LH side view of the damage to the fuselage**

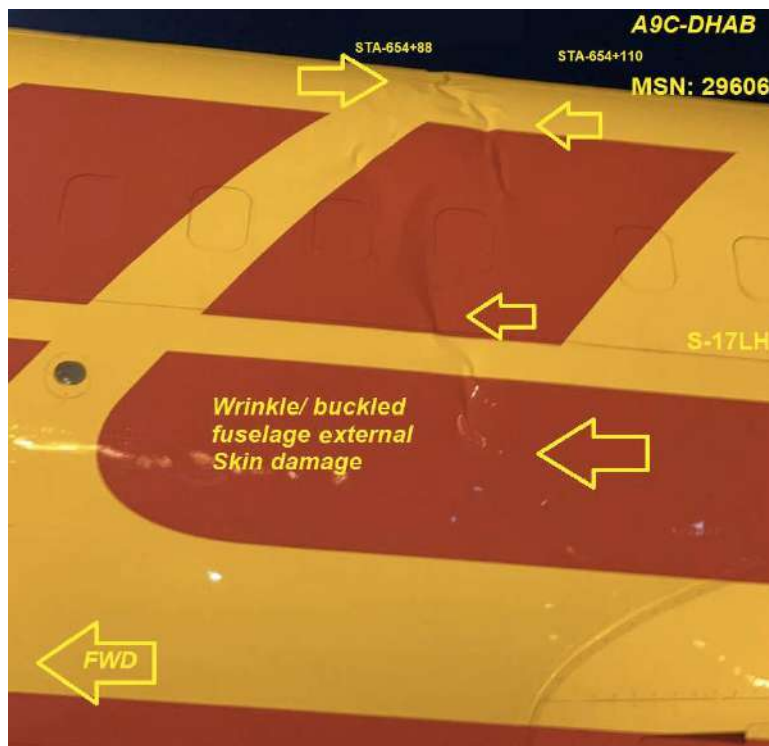
**Figure 5: Wrinkle/buckled fuselage external Skin damage LH side enlarged view**

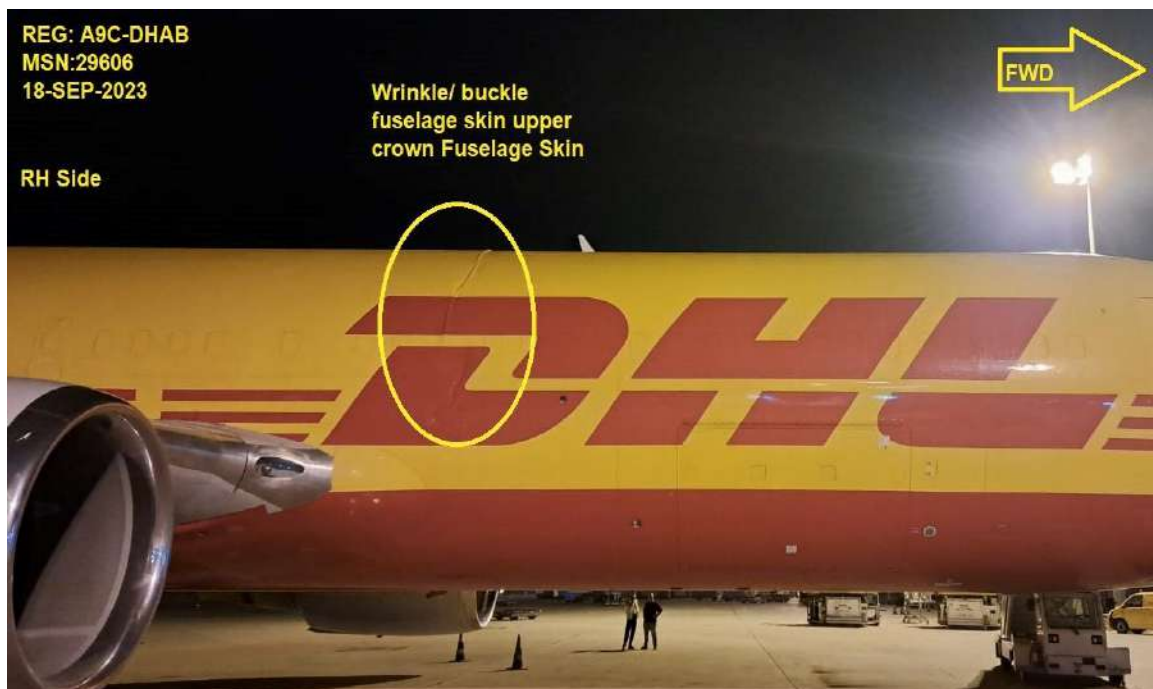
**Figure 6: Wrinkle/buckled fuselage Skin upper crown fuselage damage**

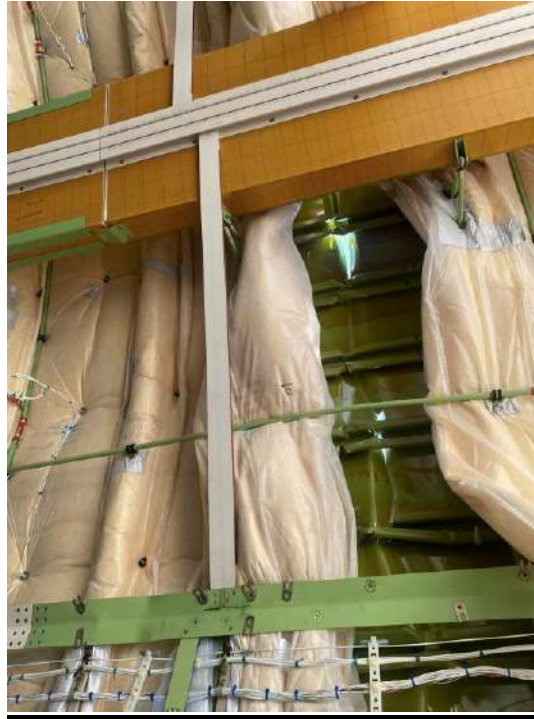
**Figure 7: Upper crown fuselage damage as seen from the inside**

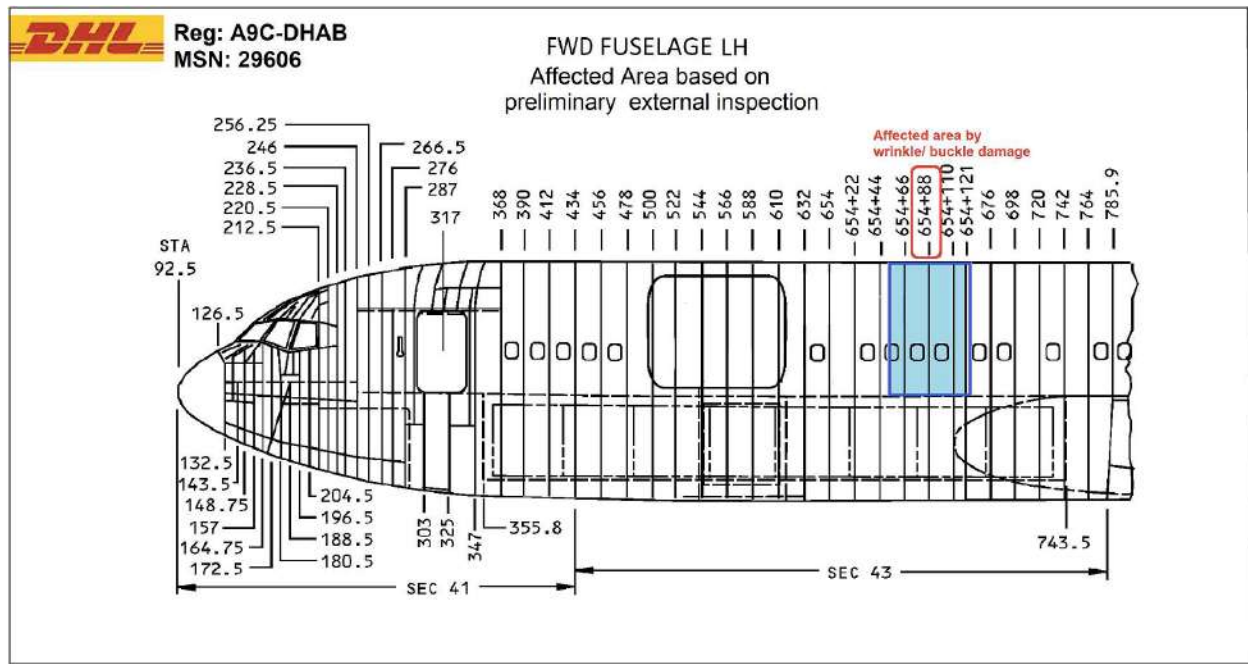
**Figure 8: FWD fuselage LH affected Area**

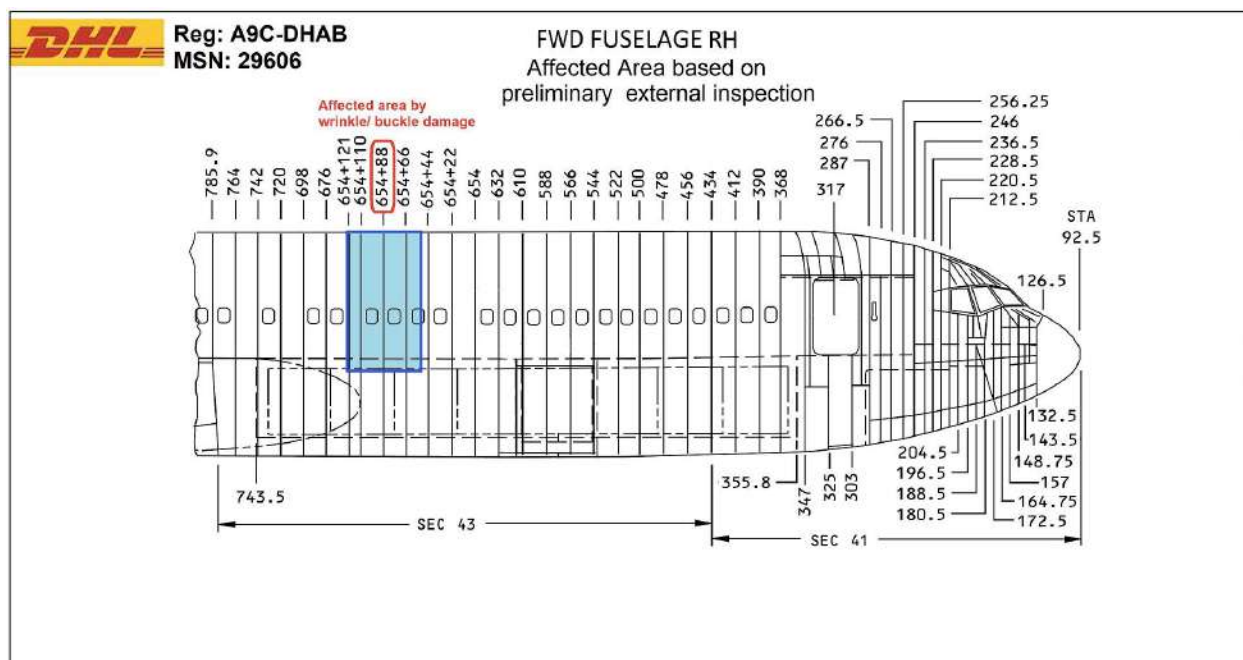
**Figure 9: FWD fuselage RH affected Area**

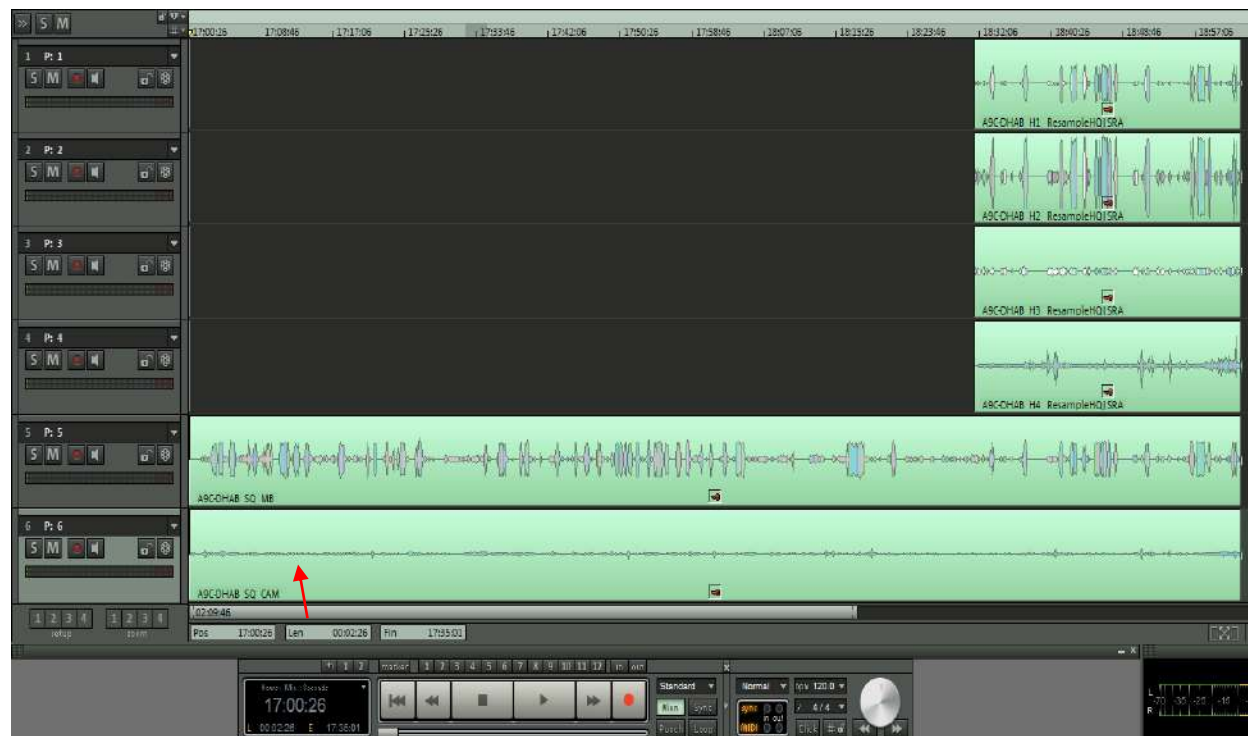
**Figure 11: CVR Recording Time Scope**

The accident occurred at 16:09 UTC, the recording starts at 17:00:26 UTC and ends at 19:02:34 UTC (Refer to figure 11 below).
