**Final Investigation Report**

**DHL - ES 160 – B767-300  
A9C - DHAB**

**18<sup>th</sup> September 2023**

**BRHIA (OLBA) - Lebanon**

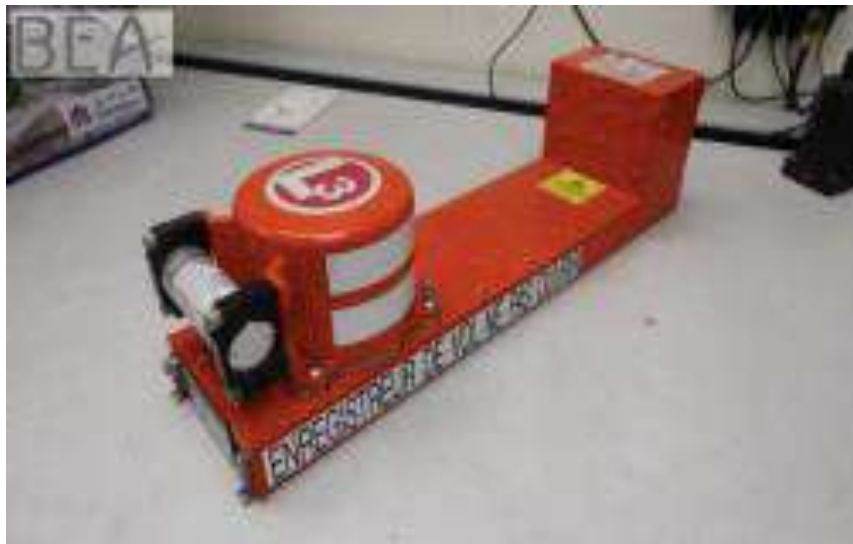
**Figure 10: Aircraft FDR**

Representative) on October 3, 2023. The BEA report is included as Appendix D to this report and incorporates plots of relevant parameters, in particular: Accelerations, aircraft pitch, main and nose gear tilt, control column position, air speed and calculated vertical speed.

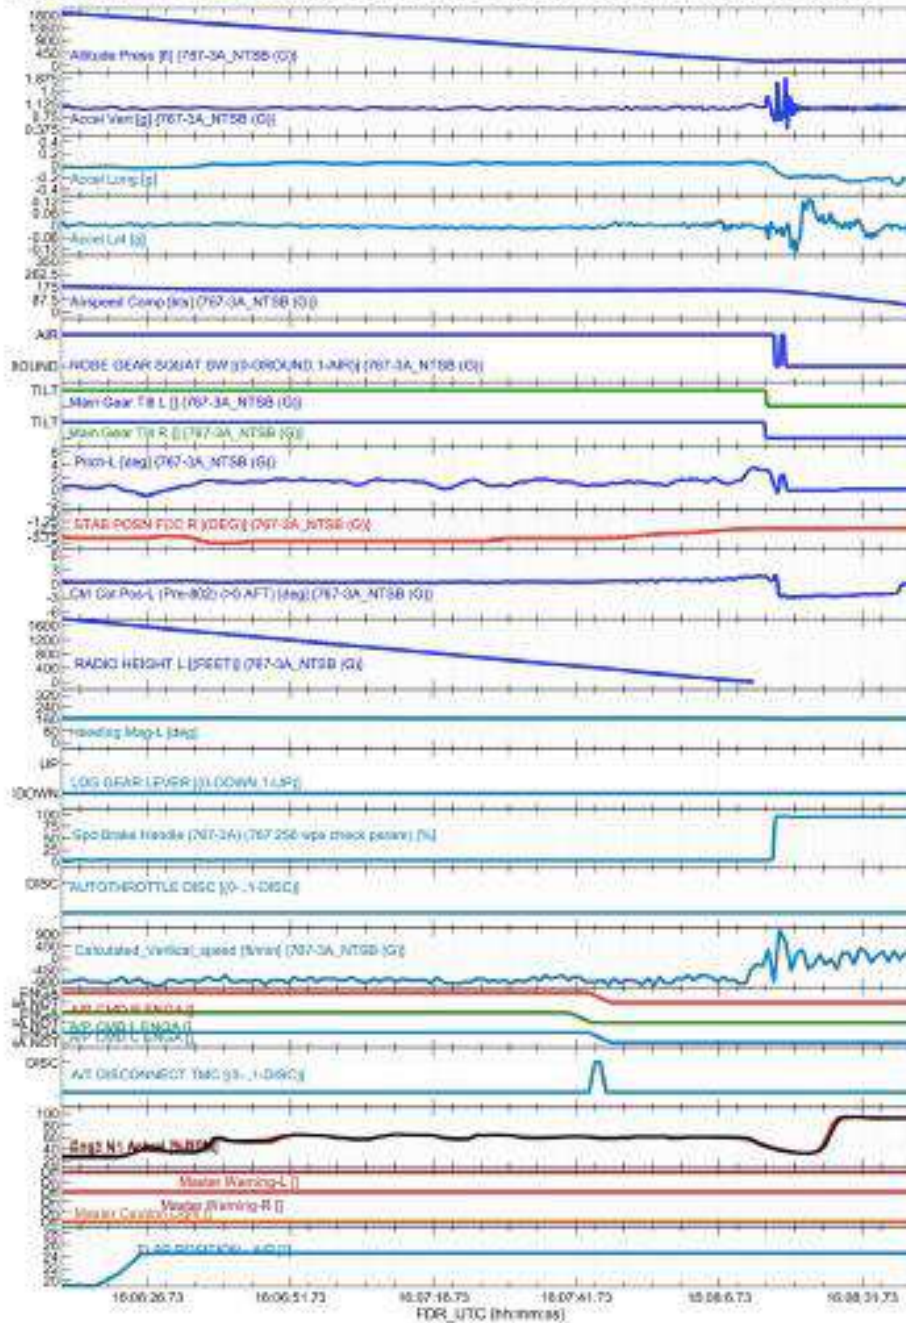
## Appendix 2: Plots of relevant parameters

Note: Particular attention must be paid to the validation of the following parameters

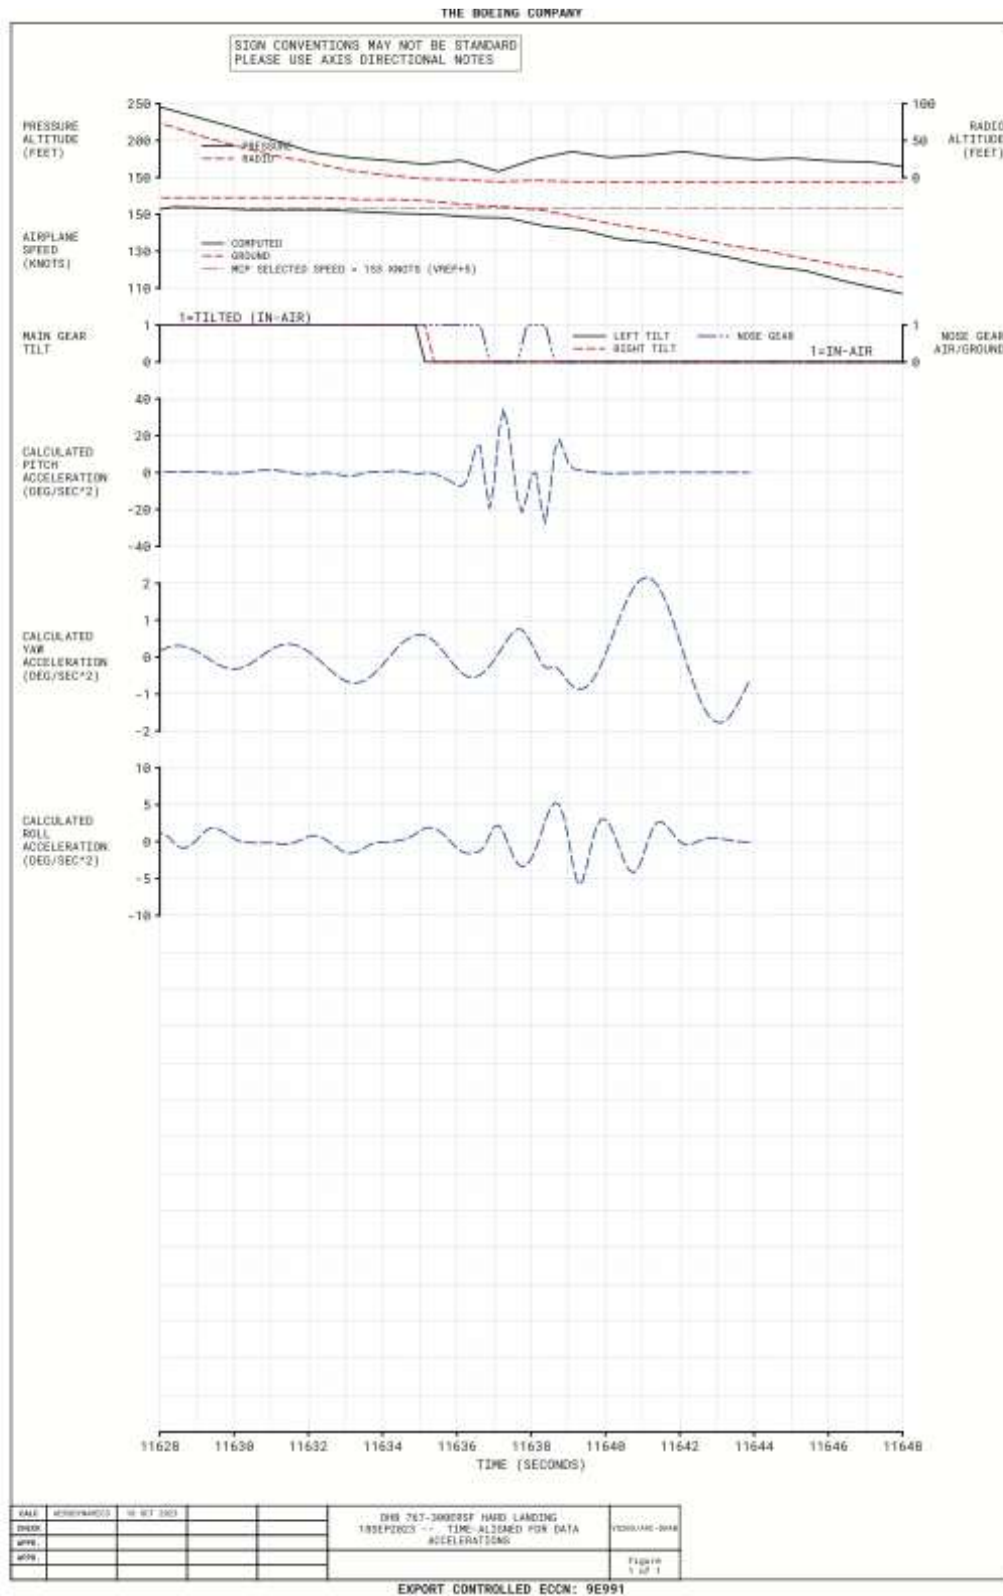
## Appendix E: Time Aligned for Data Acceleration

- a. This is based on an assessment of the parameters listed in (1) (Appendix E)
  - b. Conservative estimate of nose gear vertical loading based on the available data is potentially up to 160% of limit load because Boeing suspects it was balancing the load to reverse the pitch inertia as well as the aerodynamic pitching moment caused by the negative column deflection.
